## Inspection Report

**Property Address:**  
123 Any Street  
Austin TX 78701

# PROPERTY INSPECTION REPORT

**Concerning:** 123 Any Street, Austin, TX 78701

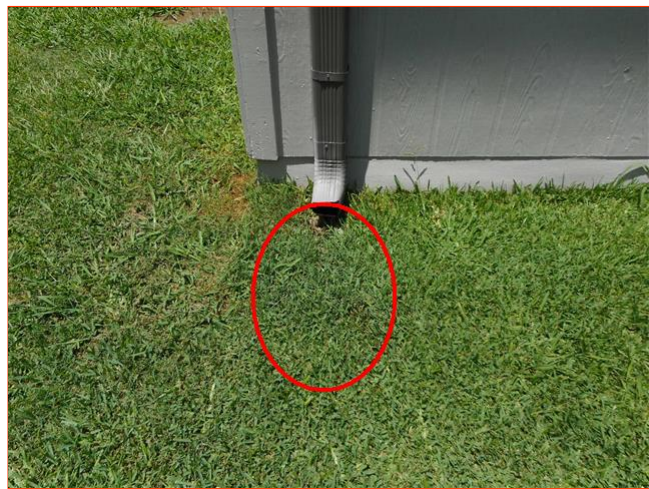
B. 1 .

The downspouts at the front and rear of the home are missing the downspout splash blocks. Erosion can occur or become worse if not corrected. I recommend installing a proper splash block at each downspout.

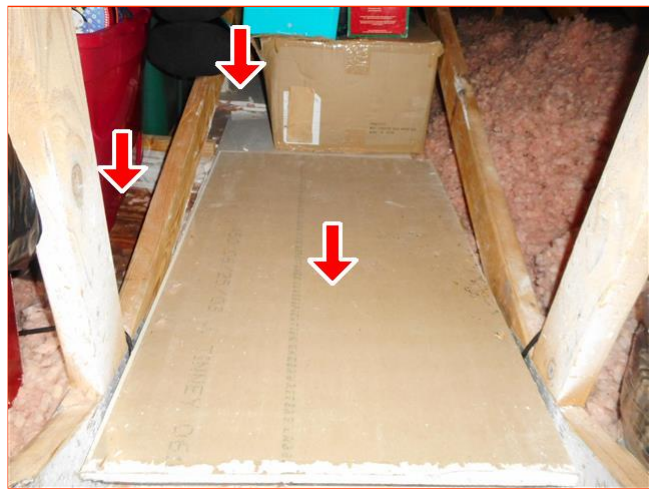
D. 1 .

The attic insulation is very thin and packed down around the attic entrance. The attic hatch is also uninsulated. This diminishes the ability of the insulation to perform as intended. This condition will cause heating and cooling costs to be much higher than necessary. I recommend adding new insulation in the attic to a minimum of R-30 or better.

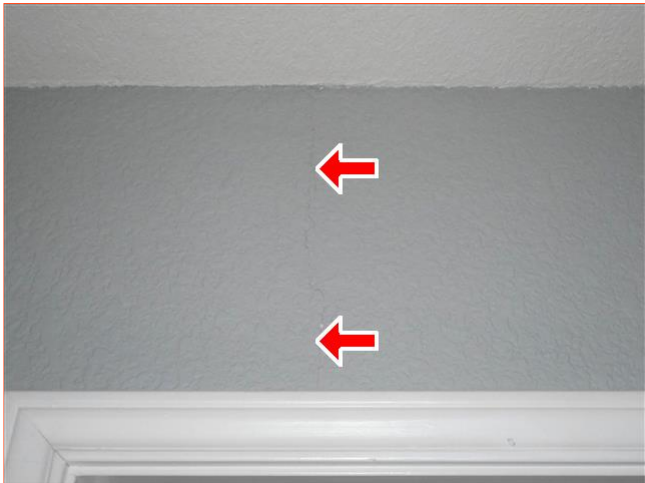
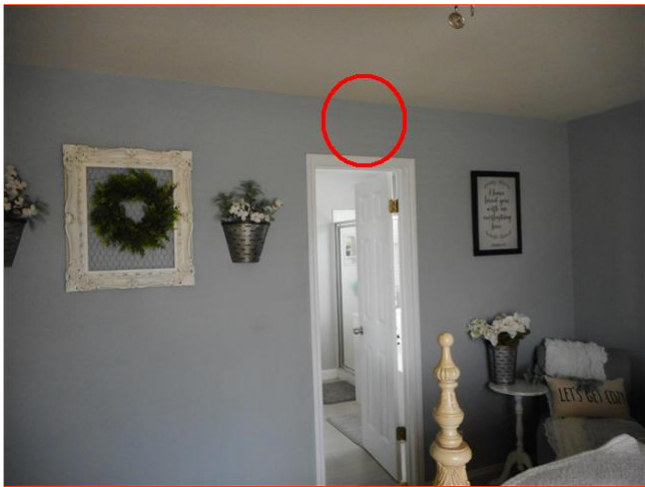
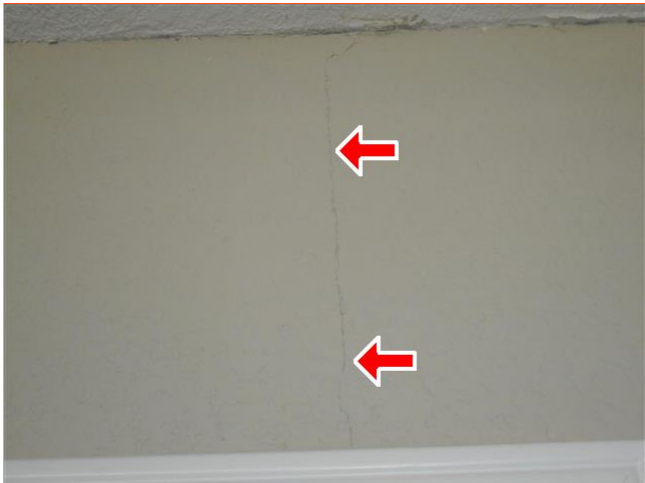
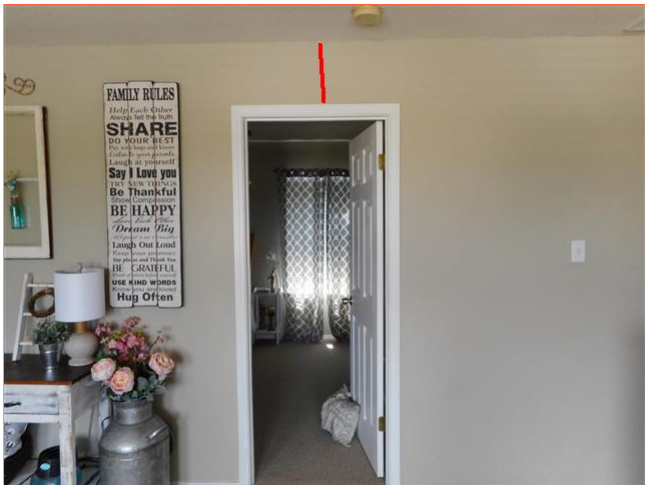
(1) The sheetrock on the wall over the entry to the master bath in the master bedroom shows some cracking. The same condition exists over the door to the southwest bedroom in the upstairs living area. This appears to be from light settlement of the structure. A qualified contractor should inspect and repair as needed.

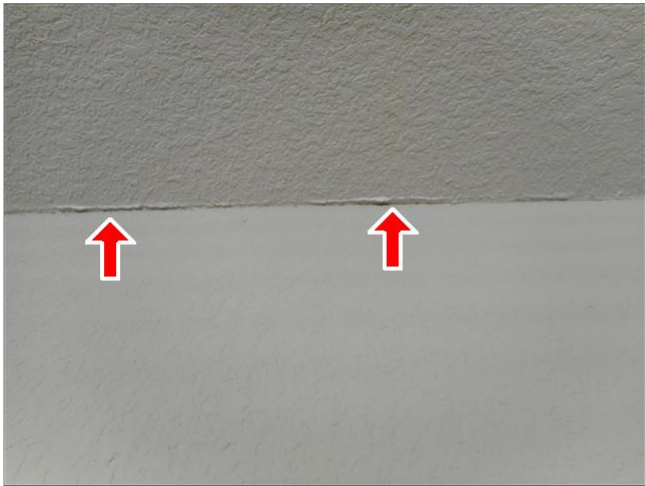
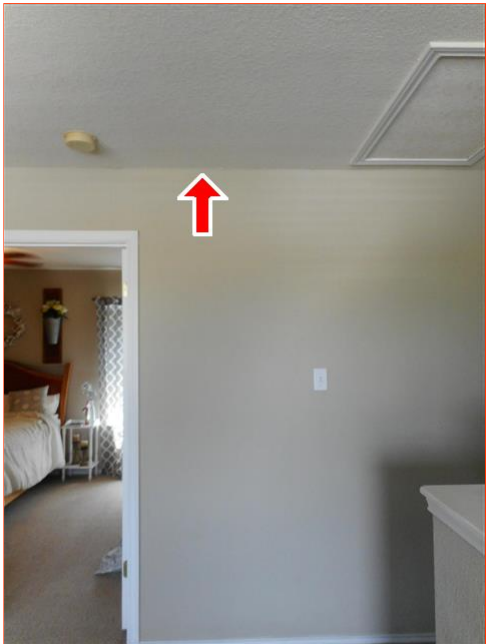
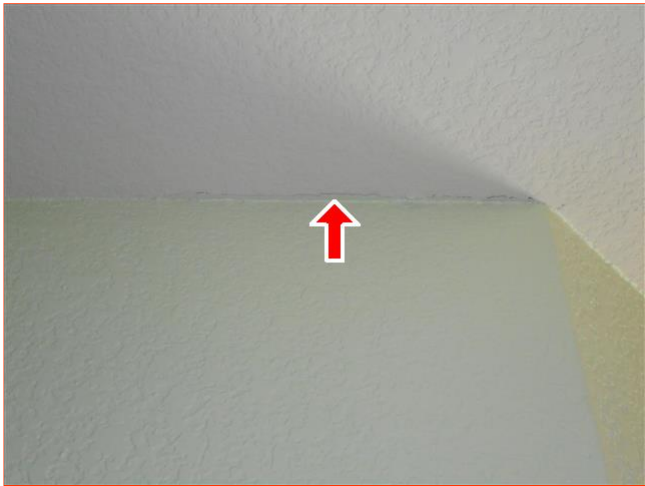
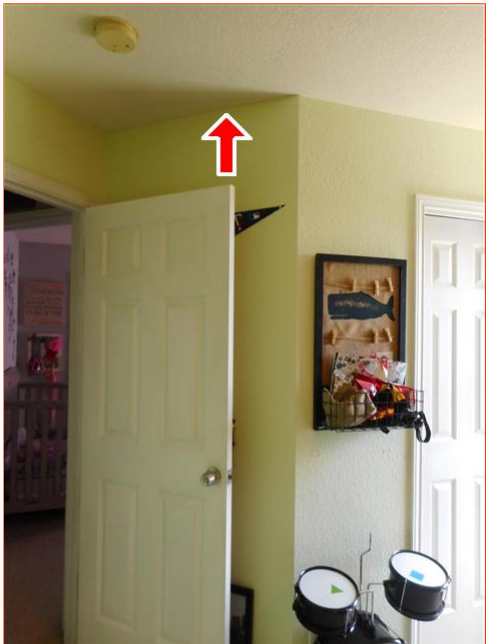
(2) The drywall material on the wall near the entrance to the southwest bedroom in the upstairs hallway shows some cracking at the intersection of the wall and ceiling. There is similar damage to the right of the door in the upstairs northwest bedroom. This may be the result of light settlement or can be caused by shrinkage of the materials. A qualified contractor should inspect and repair as needed.

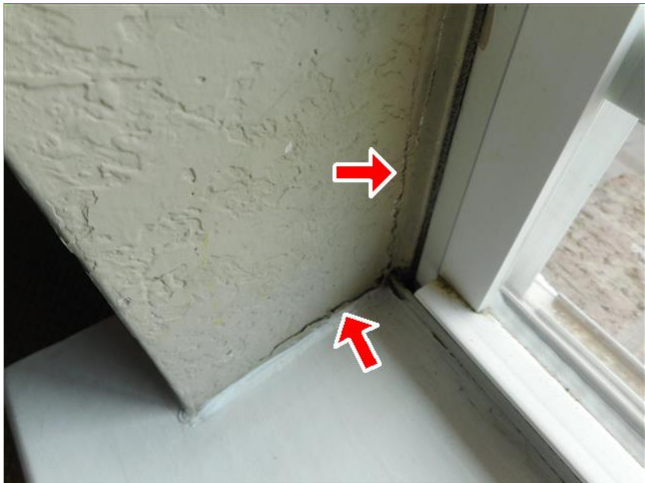
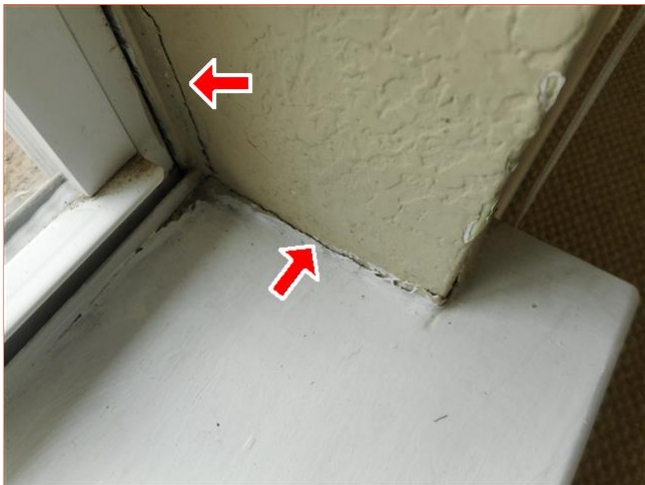
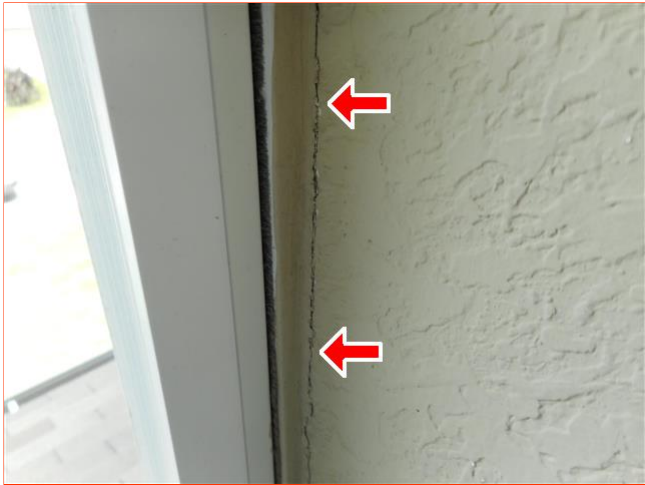
(3) The drywall on the walls at the windows at various locations around the house has deteriorated or shrinking caulking. Although vinyl-framed windows are less likely to sweat in cold weather, condensation can still occur. Because of this moisture, damage to the drywall material will occur if not corrected. A qualified contractor should inspect and repair as needed.

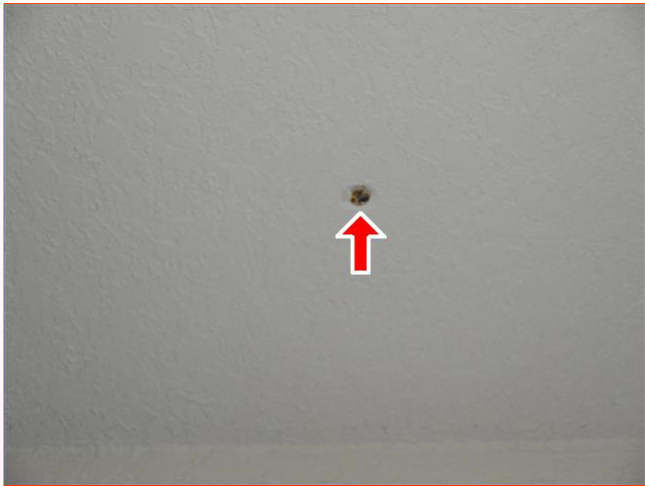
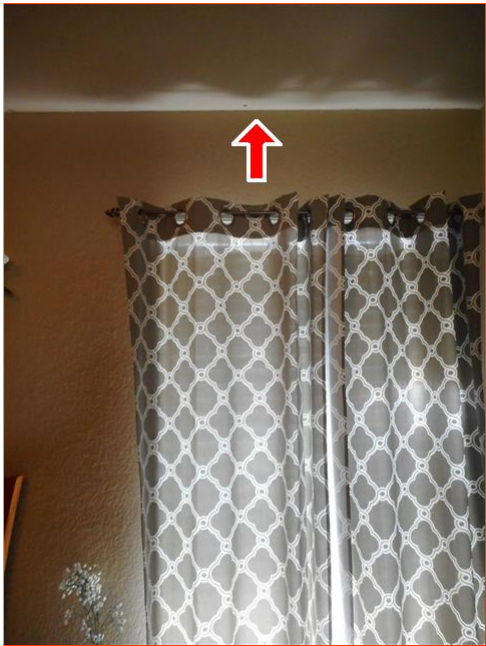
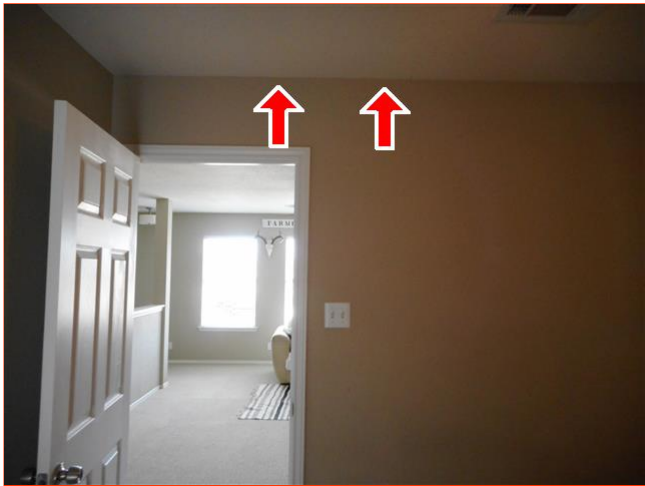
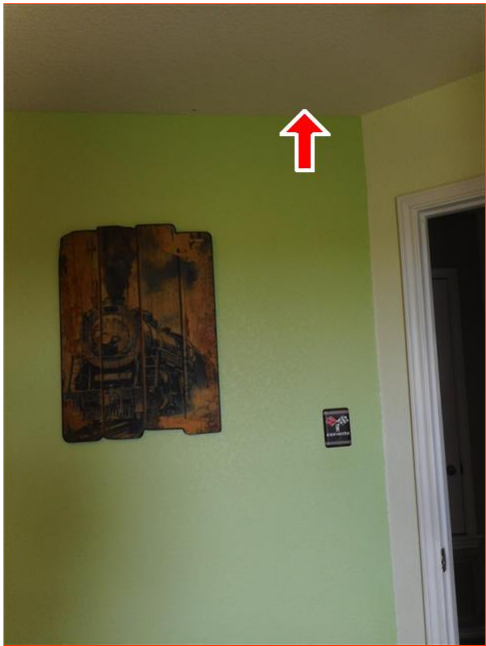
The texture on the ceilings at various locations around the house has some nail pops. The locations noted were:
- In the master closet.
  - Over the window in the southwest bedroom.
  - Over the privacy door in the upstairs southwest bedroom.
  - To the left of the privacy door in the upstairs northwest bedroom.

While this damage is not structural in nature, it needs to be repaired. A qualified contractor should inspect and repair as needed.

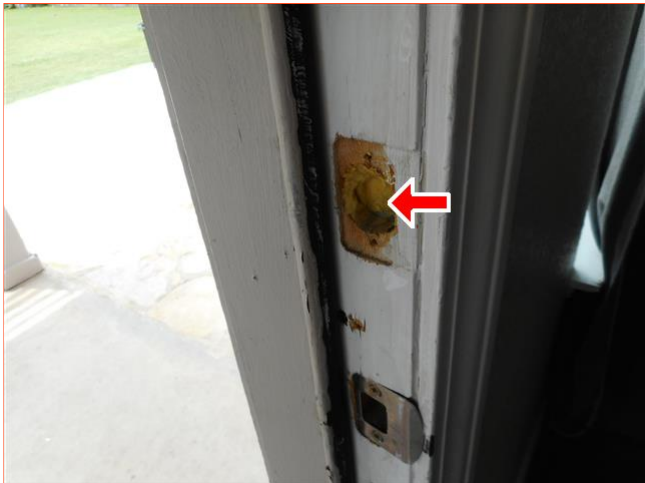
G. 1 .

(1) The entry door at the rear of the home is missing the strike plate for the dead-bolt. Damage to the door frame will occur without a proper strike-plate. I recommend repair as needed.

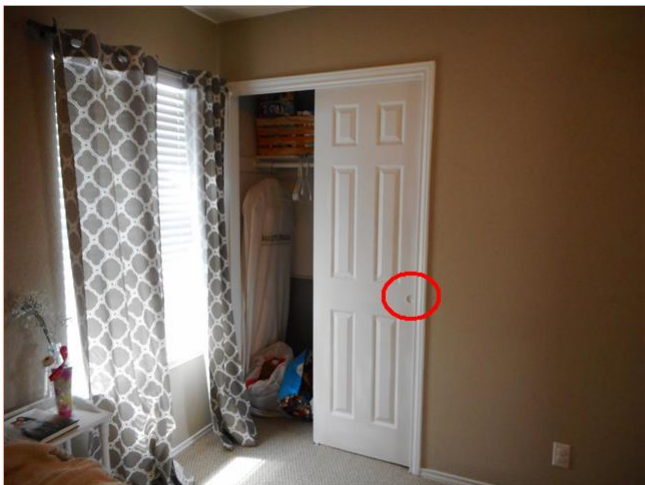
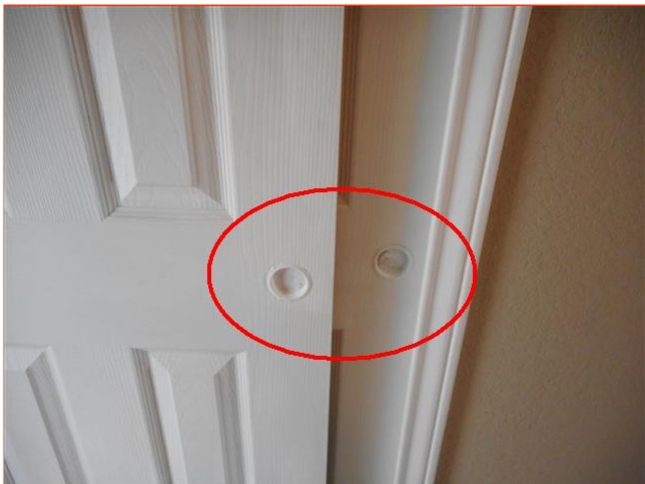
(2) The sliding closet doors in the upstairs southwest bedroom are both right-hand doors. Both doors have the pulls on the right-hand side. A qualified contractor should inspect and repair as needed.

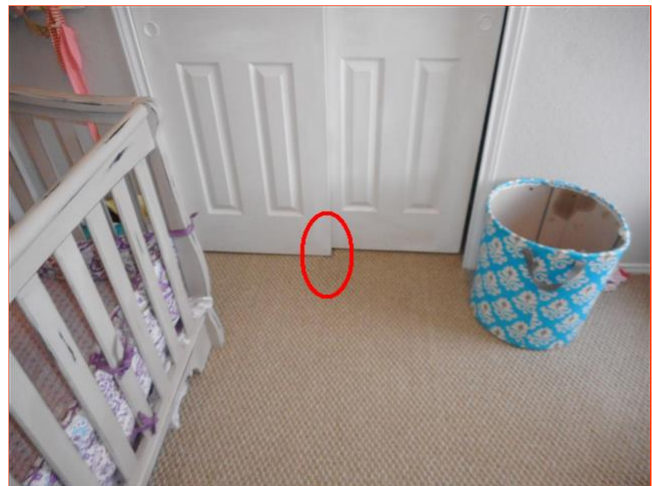
G. 5 .

(4) The sliding closet doors in the upstairs middle bedroom are missing the bottom track. This will allow the doors to swing, causing them to jump off the track. A qualified contractor should inspect and repair as needed.

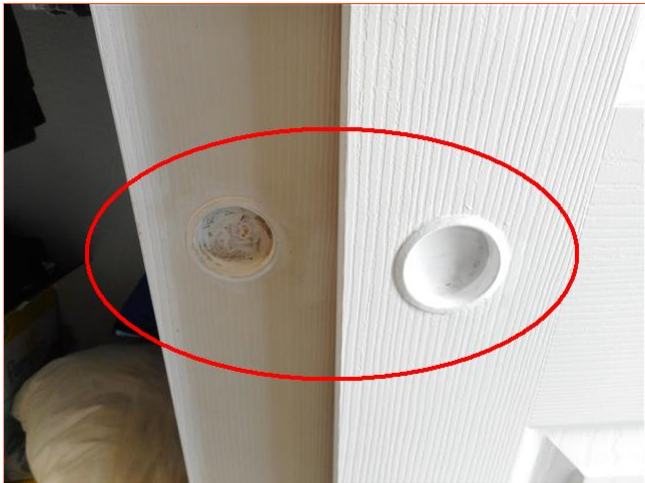
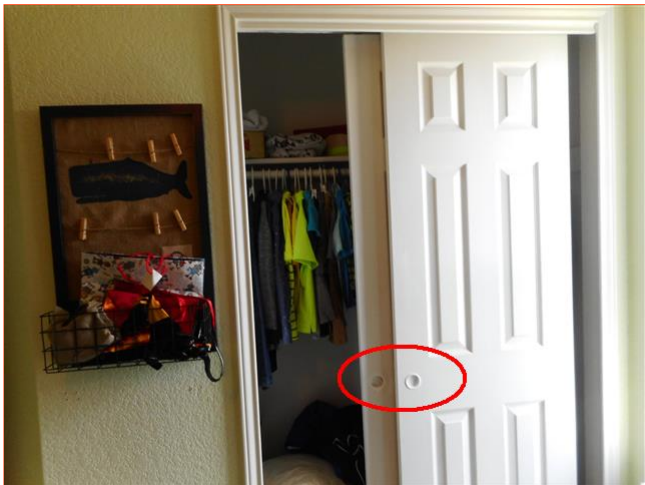
(5) The sliding closet doors in the upstairs northwest bedroom are both left-hand doors. Both doors have the pulls on the left side. A qualified contractor should inspect and repair as needed.

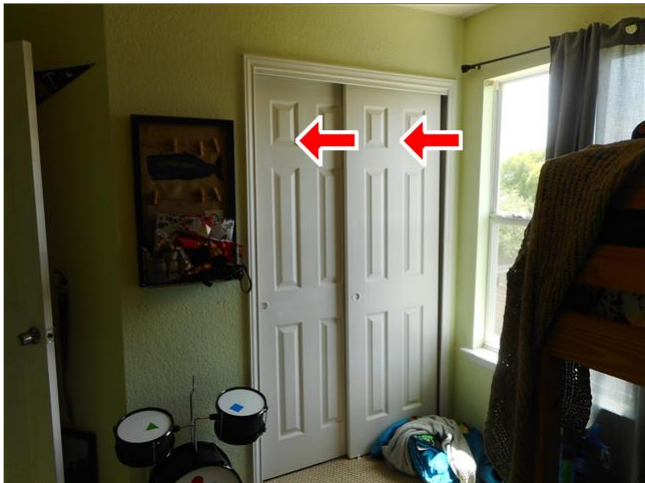
G. 8 .

(6) The sliding closet doors in the upstairs bedroom fall off the track when operated. The opening may be out of square, or the doors need adjustment. A qualified contractor should inspect and repair as needed.

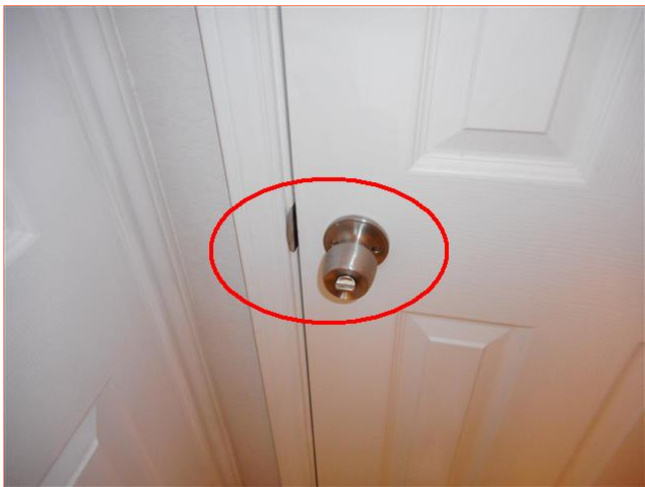
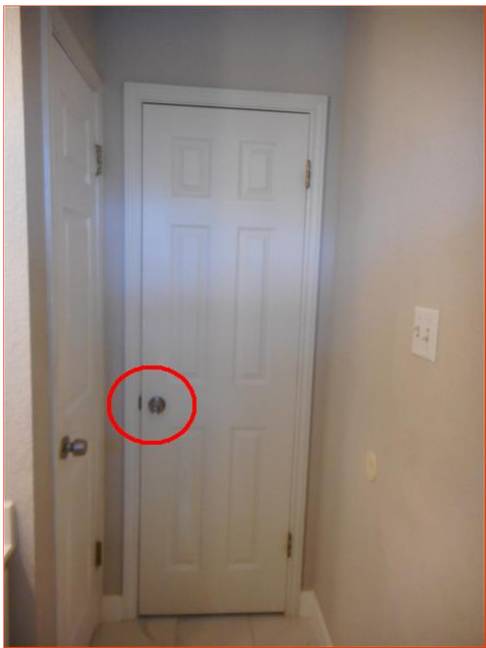
(7) The privacy door at the upstairs hall bath needs a strike and latch adjustment to shut and latch properly. A qualified contractor should inspect and repair as needed.

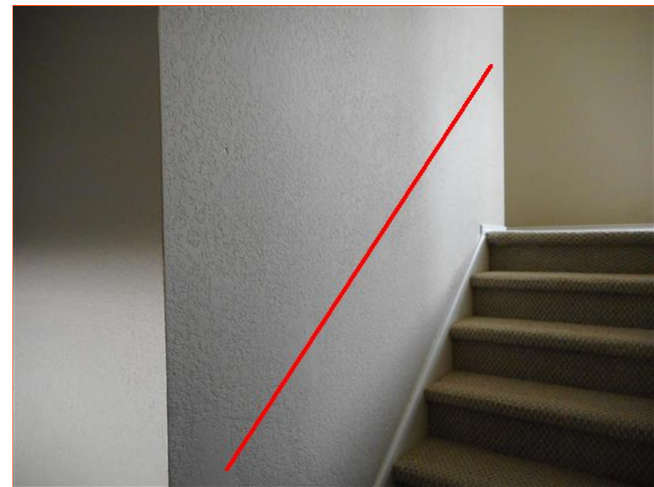
I. 1 .

The hand/guard rail for the upper flight of stairs is missing. A fall or injury could occur if not corrected. A qualified contractor should inspect and repair as needed.

According to the International Residential Code (IRC), **(R315.1) Handrails**. Handrails having minimum and maximum heights of 34 inches and 38 inches, respectively, measured vertically from the nosing of the treads, shall be provided on at least one side of stairways. All required handrails shall be continuous the full length of the stairs with two or more risers from a point directly above the top riser of a flight to a point directly above the lowest riser of the flight. Ends shall be returned or shall terminate in newel posts or safety terminals. Handrails adjacent to a wall shall have a space of not less than 1.5 inches between the wall and the handrail.

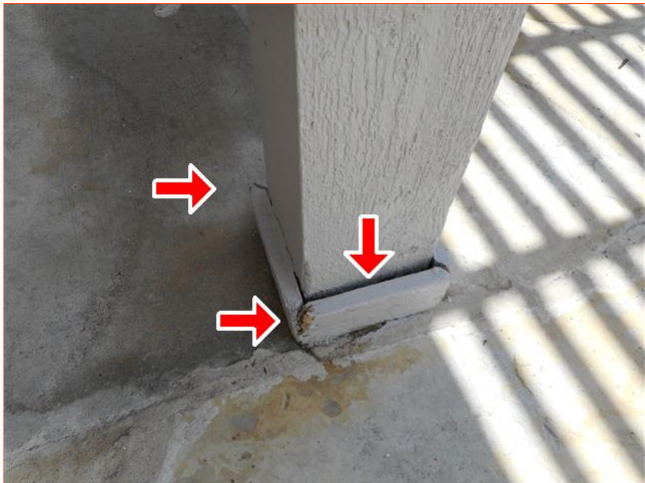
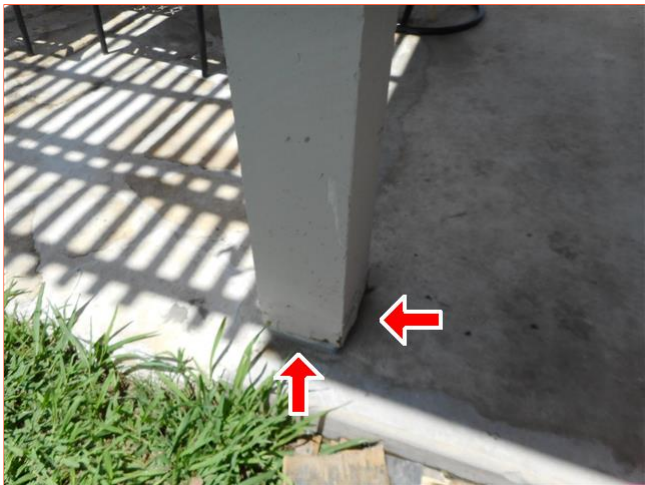
The post trimmers on the covered porch at the rear of the home are damaged or missing. A qualified contractor should inspect and repair as needed.

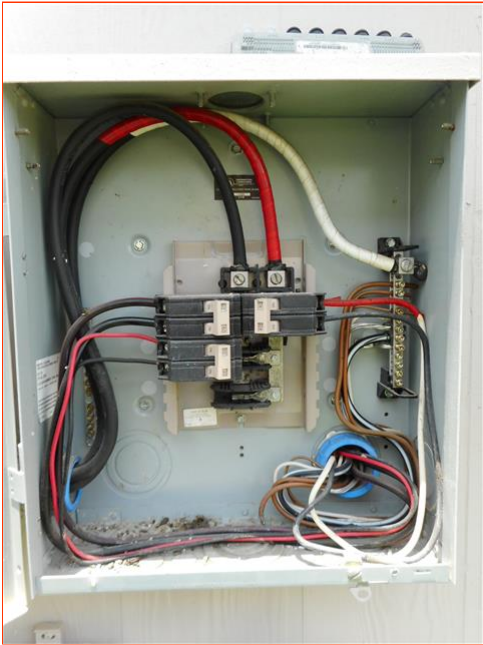
(1) The main panel box is located at the exterior near the front on the south side of the house. The box is clean, in order, and properly labeled.

A. 1 . Interior view of the main panel.

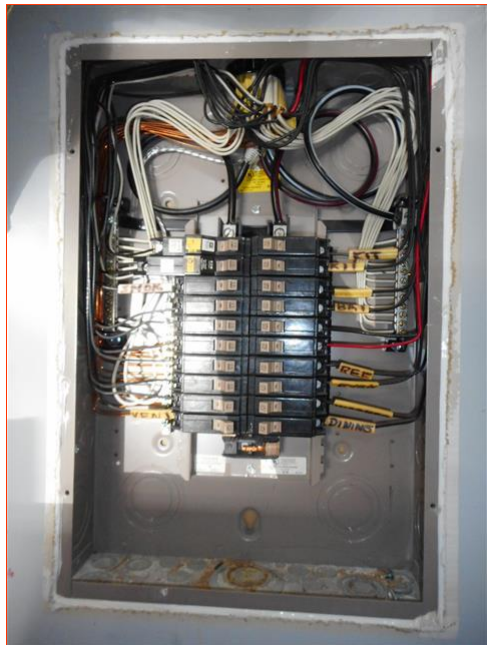
- ☒ (2) The sub-panel box is located in the garage. The box is clean and in order but lacks proper labeling. I recommend labeling the breakers as needed.

**Rationale:** The panelboard circuit directory must be permanent and legible. In many homes, the door of the panel board cabinet reveals illegible markings. The outlets a circuit serves are a mystery to an observer because the markings on the panel board have become faded or are incomplete. Some electricians and installers write only such things as "General Lighting" or "Plugs" to satisfy this section. Each circuit identification must be detailed enough to distinguish the circuit from all other circuits. Obviously, six circuits labeled "Lights" cannot be distinguished from each other, and such labels are a violation of this section. Factory-made panel labeling kits are available that will facilitate compliance with the intent. Of course, acceptance of such markings is according to the judgment of the code official, but if the markings are not legible, a code violation exists. Correct terminology must be used. Obviously, the circuits for appliances such as dishwashers, disposals, furnaces, etc. should be marked. A potential hazard exists where circuit breakers are mislabeled or ambiguously labeled because the occupants or electrical workers might not actually be de-energizing what they intend to de-energize.

A. 2 . Interior view of the sub-panel.

I recommend a licensed electrical contractor properly re-label the panel circuits for electrical safety.

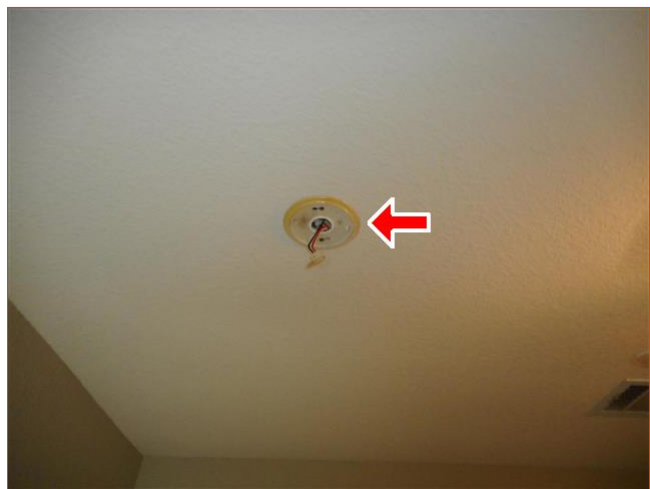
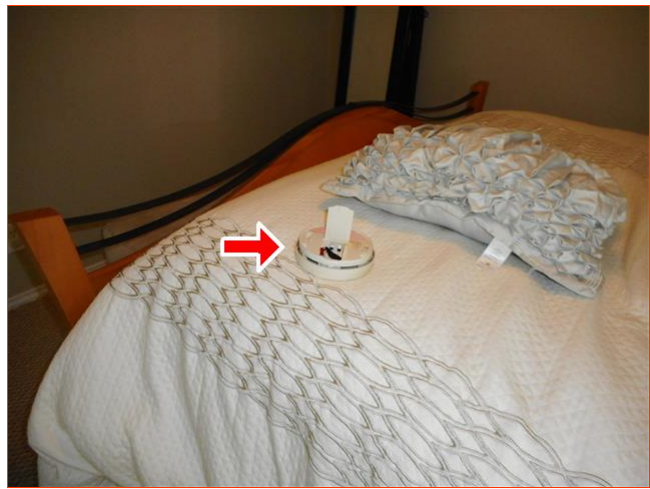
Without a working smoke detector in this area of the home, you may have no first alert to a possible fire. I recommend replace as needed using a qualified person.

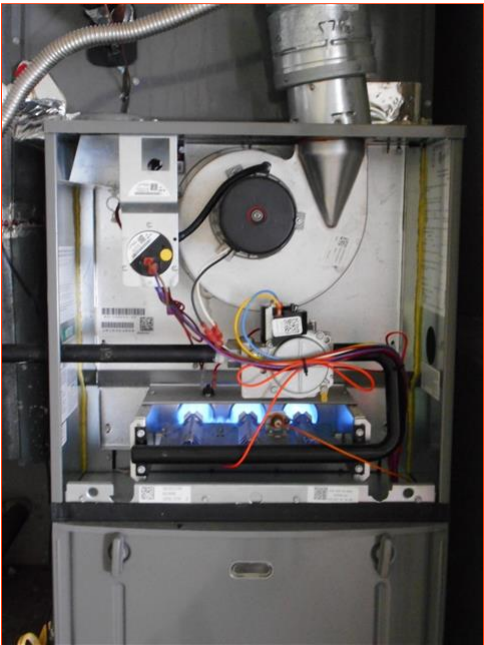
A. 1 .

**Comments:**  
(1) The manufacture date on the furnace is 04/2015.

Examination of the visible portions of the heat exchanger revealed a clean unit. The furnace is pilot-less and operated through the start-up sequence, ignition, run, and cool-down as expected.

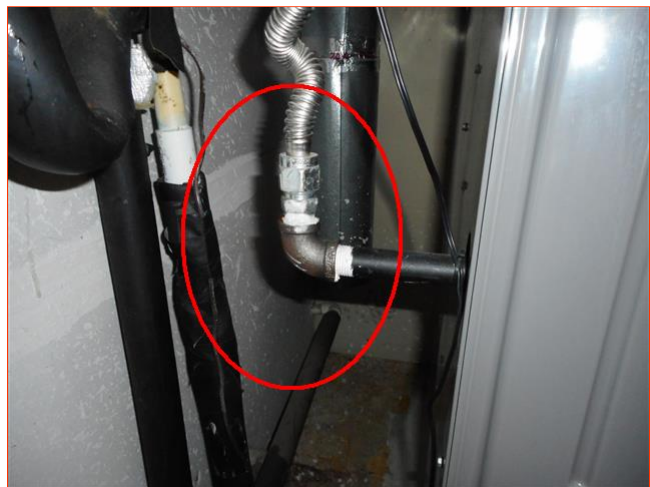
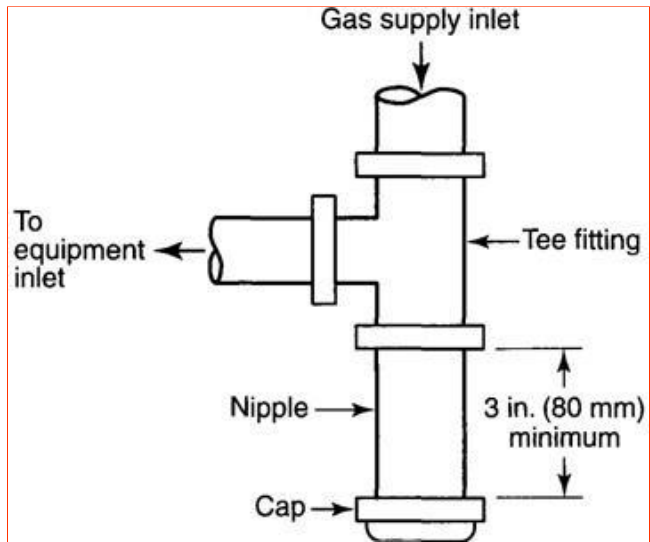
(2) The gas connection at the furnace is missing the debris or sediment trap.

sediment trap shall be either a tee fitting having a capped nipple of any length installed vertically in the bottom-most opening of the tee or other device *approved* as an effective sediment trap. Illuminating *appliances*, ranges, *clothes* *dryers*, and outdoor grills need not be so equipped.

I recommend installation of a proper debris or sediment trap by a licensed plumbing contractor.

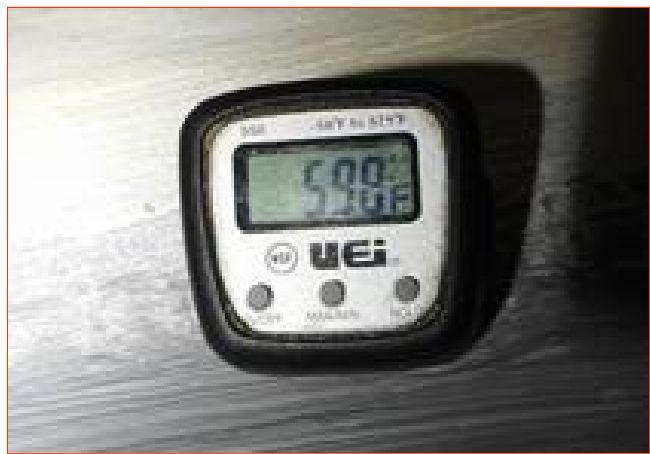
An ambient air test was performed by using thermometers on the air handler of the air conditioner to determine if the difference in temperatures of the supply and return air is between 12° and 22°, which would indicate that the unit is cooling as intended. The supply air temperature on your system read 59.8°, and the return air temperature was 78.4°. This indicates that the range in temperature drop (18.6°) is normal.

B. 1 . Supply air temperature.

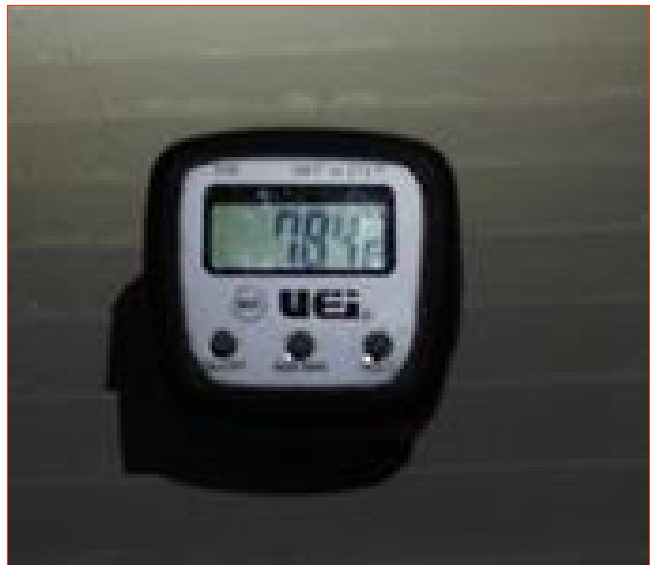
B. 2 . Return air temperature.

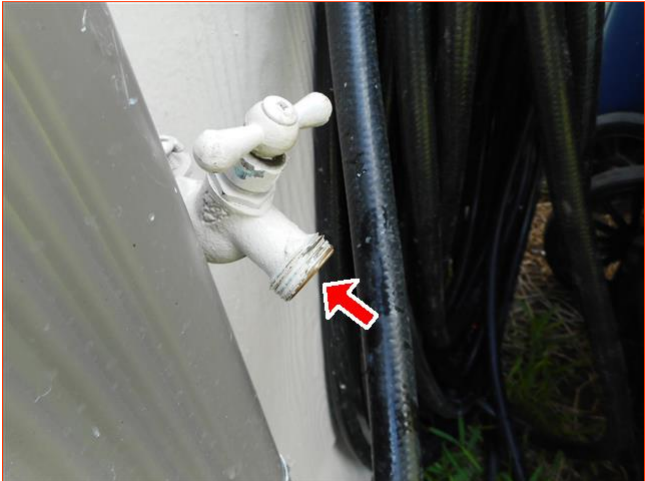
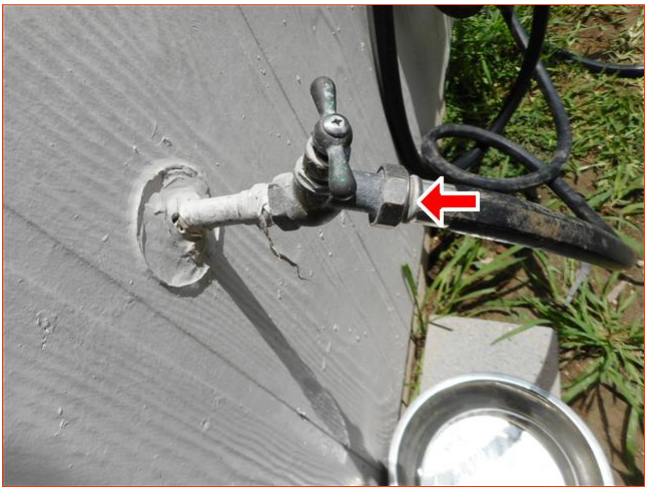
(1) The hose bibs at the front and rear of the house are missing the anti-siphon devices. This can allow a possible cross-connection, allowing water to be siphoned back into the potable water supply, and it should be corrected. A qualified person should repair as necessary.

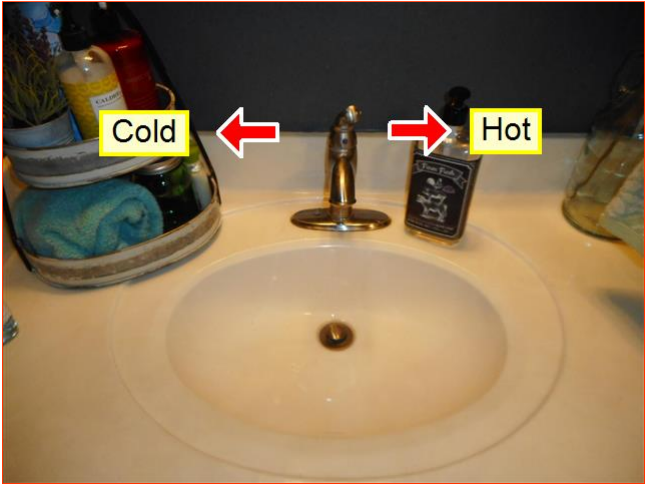
A. 3 .

(2) The sink faucet in the downstairs half bath is reversed (hot is cold, cold is hot). This can lead to confusion and possible scalding and should be corrected. A licensed plumber should repair or correct as needed.

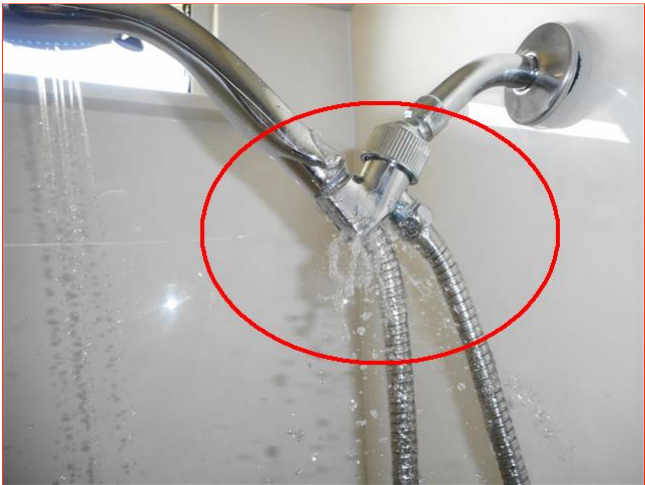
A. 4 .

(3) The shower head in the upstairs hall bath leaks around the top connections. A contractor should repair or correct as needed.

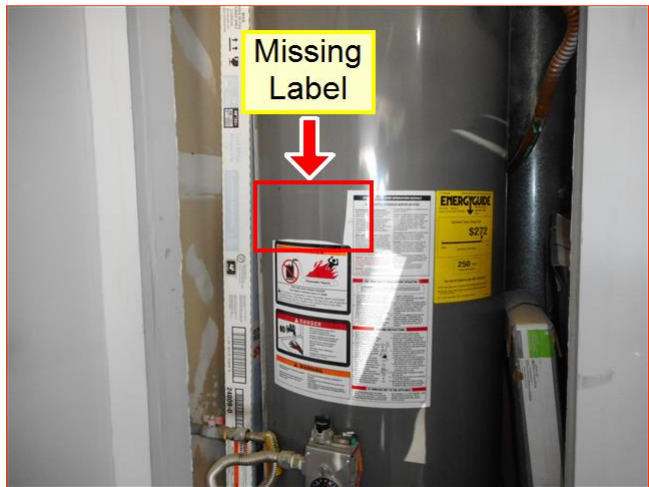
C. 1 .

The hot water heater is a gas unit of unknown brand. The manufacturer's label has been removed. The unit appears to be operating properly. I recommend flushing the tank at least once per year to remove

- Hook a garden hose up to the bottom drain valve. Place the garden hose in a position to allow full discharge of the water through the hose (in the yard or flower bed or the bath tub).
- Open the drain valve wide open. DO NOT CLOSE OFF THE INCOMING COLD WATER SUPPLY TO THE HEATER.
- Run the water out of the hose until the water runs clear.

When the water is clear, shut off the bottom drain valve and remove the garden hose.

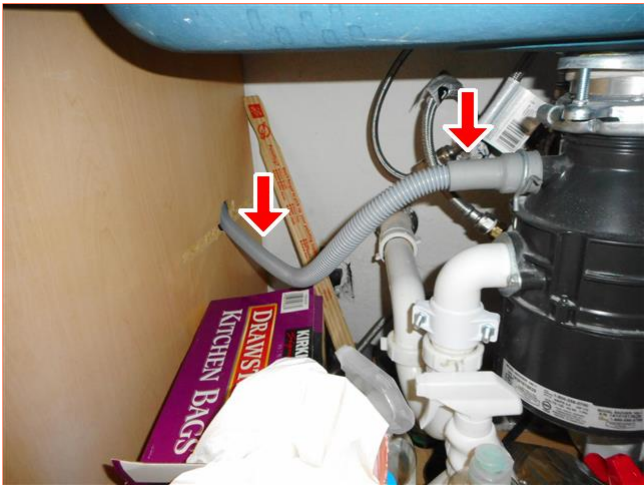
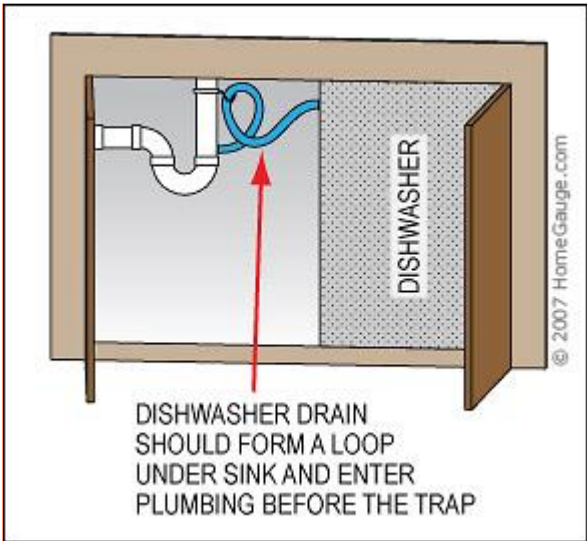
(2) The dishwasher drain line at the kitchen sink should be mounted and form a "loop" under the sink to prevent a possible back-flow of contaminants. A qualified person should repair as necessary.

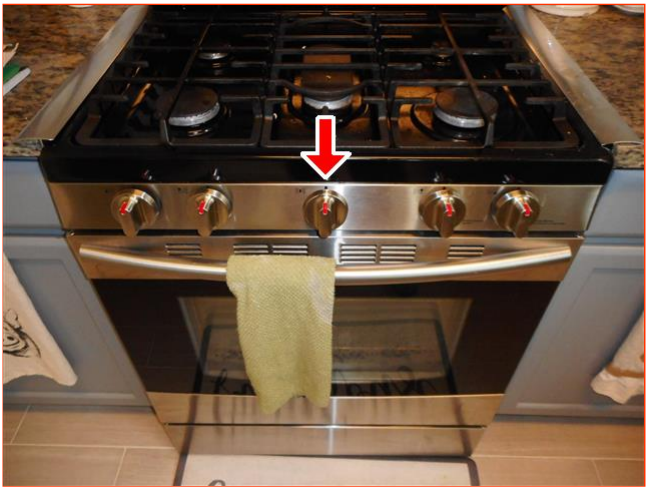
D. 1 .

(2) The control knob for the middle burner on the cooktop is damaged. I recommend repair or replace as needed.

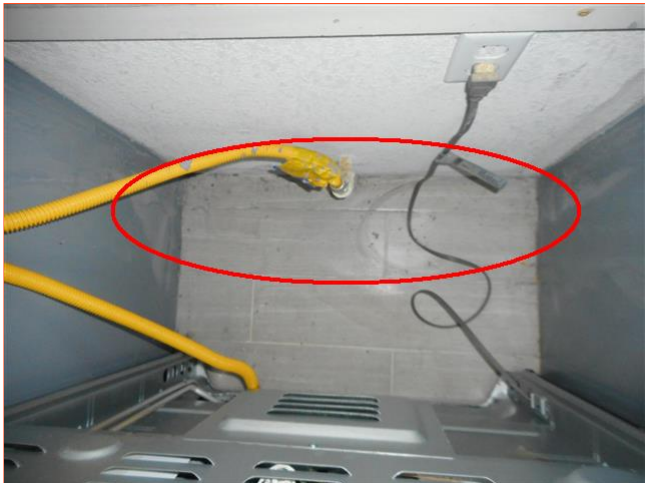
D. 2 .

(4) There is **no anti-tip device installed** on the kitchen range. This is a safety issue that needs correction. A load placed on the oven door can cause the range to tip over without the anti-tip device installed. I recommend installing a proper anti-tip device on the kitchen range.
